Wade's Bridge, Aberfeldy

Summary Notes from Inspection

July 2023

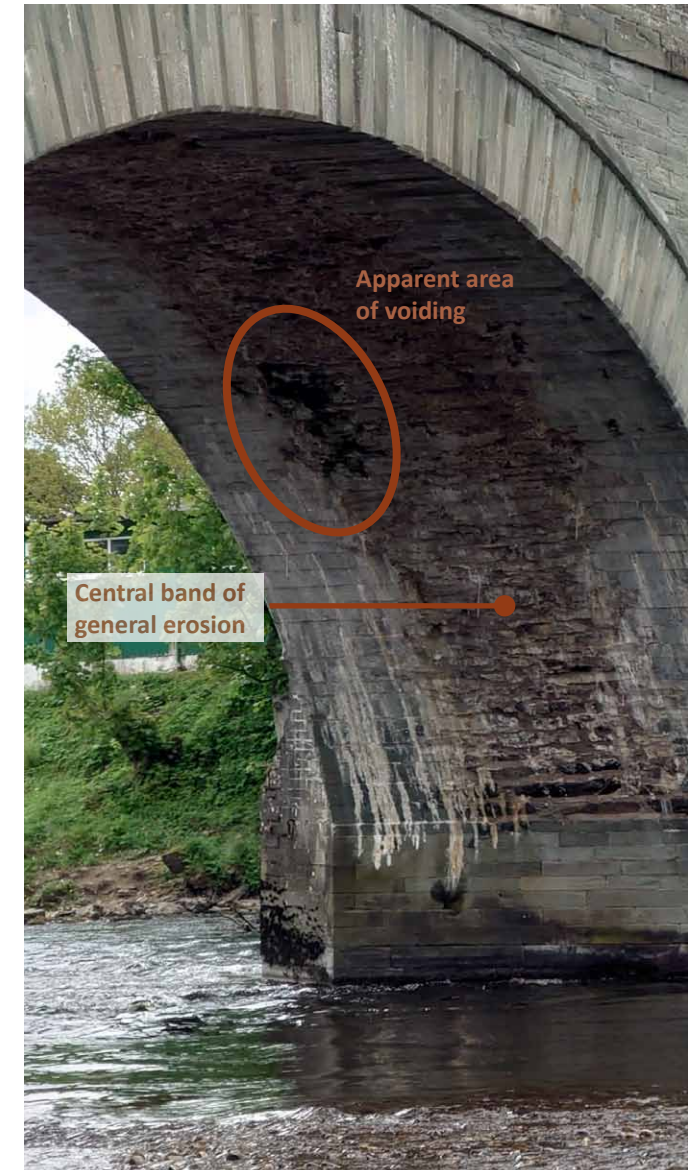
More significantly, on the underside of the main arch, there is a central band of erosion on the underside of the bridge and what appears to be a more substantial area of void towards the downstream side on the arch. The cause of this, and the potential implications for the structure, require further investigation. Previous experience however suggests that moisture penetrating the bridge deck is a likely cause.

Underside of main arch from upstream side of north bank showing areas of erosion and voiding.

Although the ongoing work by the local authority to resurface the road may reduce the amount of water penetrating into the structure going forward it is unlikely to prevent it all (especially at junctions with the parapet etc.) without proper detailing and waterproofing, which should be considered in any future repairs to the structure.

Subject to the result of a more detailed inspection of the bridge, which should be undertaken by an accredited conservation architect and structural engineer, none of the defects identified in our initial assessment of the bridge require urgent or immediate attention but it would be advisable to properly assess and plan for repairs to be undertaken within the next five years to prevent and retard further deterioration of the structure.

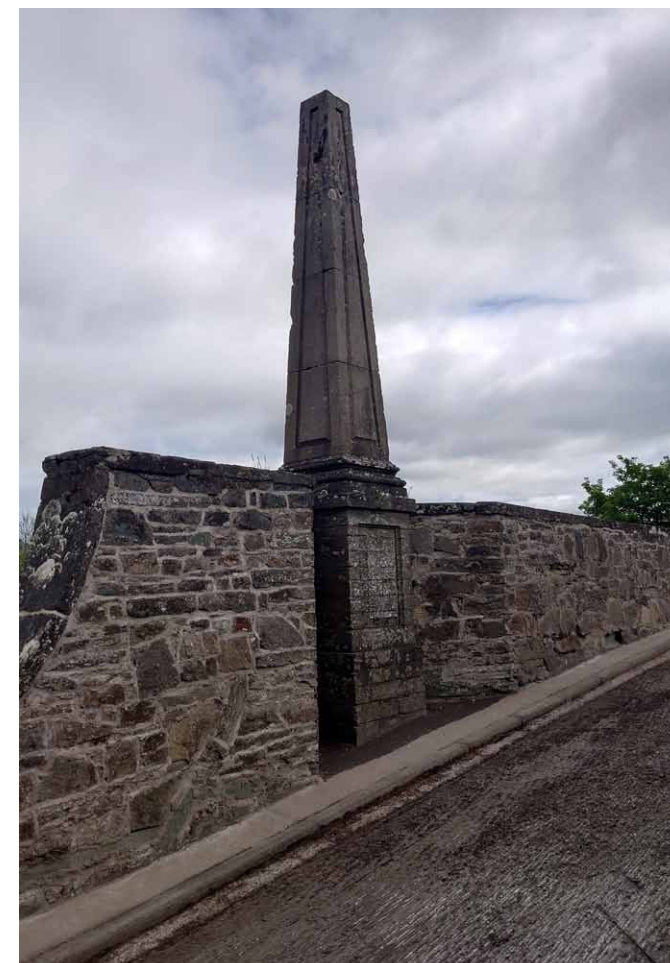
There were however areas of deterioration noted; particularly weathering/erosion to the masonry in the parapet walls above the road deck and failed or missing

mortar pointing on the inside faces of the parapet walls. Based on our observations and the 'unsolicited report' prepared by Bill Harvey in July 2022, the most likely cause of this road salts, and the inappropriate use of cement based mortar in recent repairs.

Inside face of downstream parapet wall showing eroded masonry, failed mortar pointing and inappropriate use of cement based mortar causing further deterioration to walls.

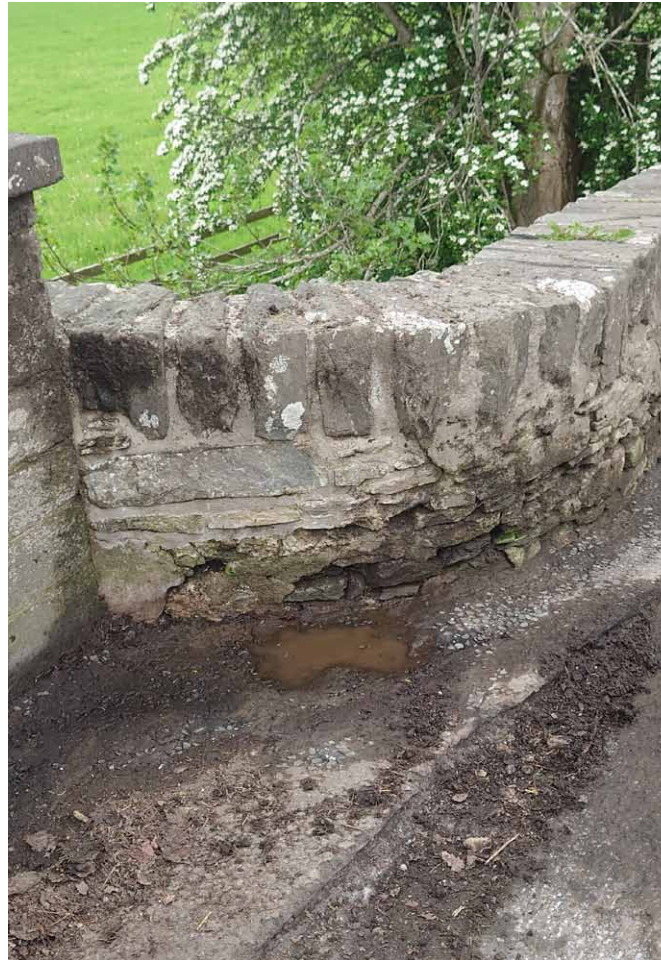
Inside face of upstream parapet wall showing eroded masonry and failed mortar pointing.

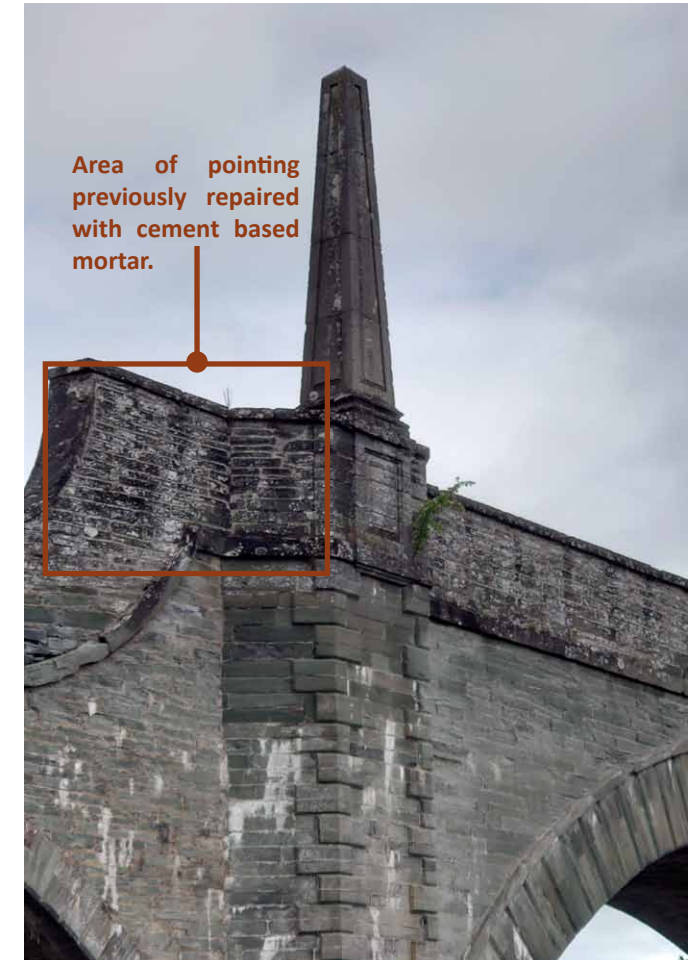
Upstream elevation from north bank showing vegetation growth in failed mortar joints and inappropriate use of cement based mortar causing further deterioration to walls.
